# CONFORMAL COATING PHOTOGRAPHIC GUIDE

# CONFORMAL COATING INSPECTION & DEFECT GUIDE

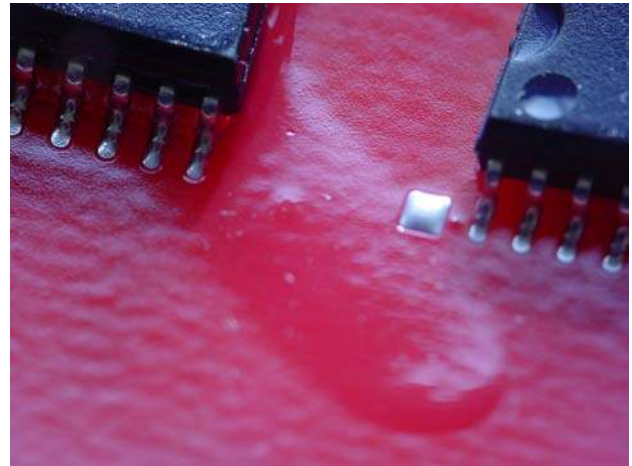
## Coating Runs

Coating runs are most likely to be associated with a dip coating process. The speed of withdrawal from the coating, the solids content or coating contamination may affect coating drainage. Coating runs will indicate the direction of withdrawal from the coating. Runs can also be seen on spray coating or selective de-wetting when boards are stacked vertically for curing

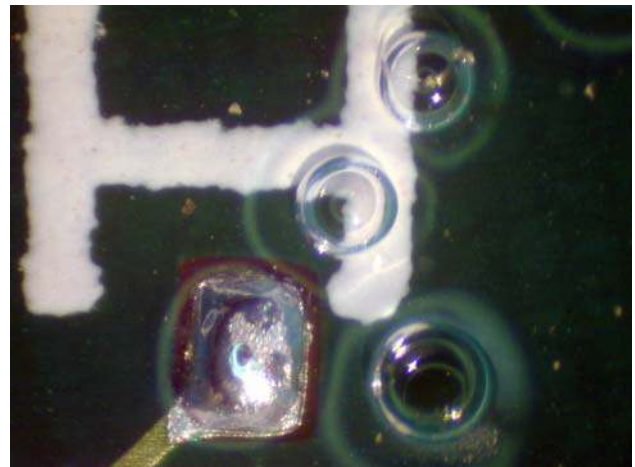
## Fish Eye Bubbles

As the name suggests the bubbles resemble large fish eye balls. Often the term is just applied to normal bubbles in the surface of the coating. They can be associated with small particles of contamination in the bubbles. If the bubbles are small and not bridging terminations or adjacent tracks they are normally acceptable

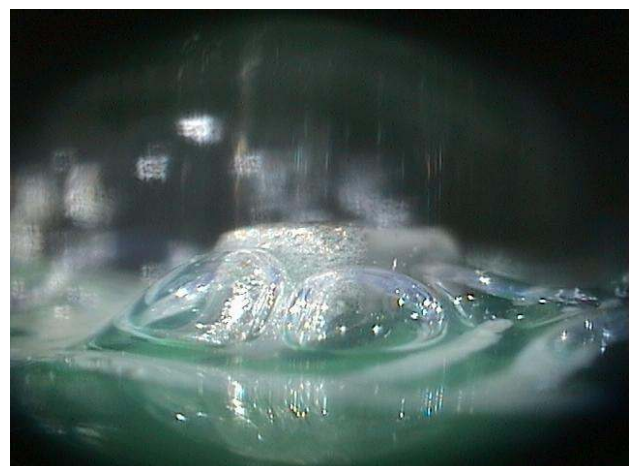
## Bug Eye Bubbles

Very large bubbles in the coating, most commonly seen around component bodies or through holes where expanding air or solvent has allowed bubbles to form in the coating. This is most commonly associated with a curing cycle not appropriate to the coating type or thickness

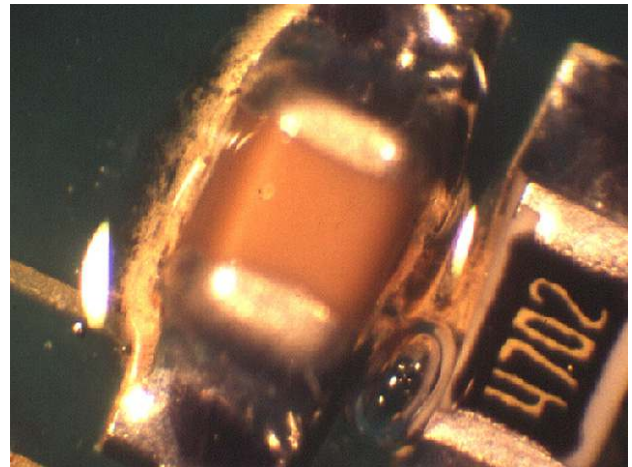
## Corrosion under Coating

A reaction can take place under the coating on the printed board surface. A chemical reaction can lift the surface of the mask. This reaction may continue during the operation of the product at elevated temperature, applied voltage or in other extreme environmental conditions. The use of highly activated residues under the mask may also cause this reaction in a non operating environment

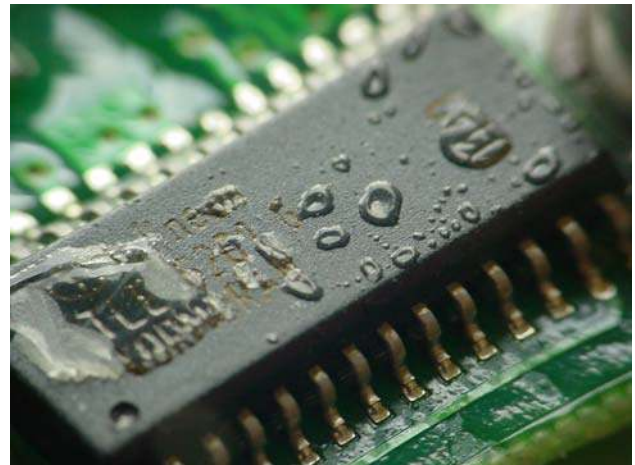
## Non/De-Wetting

Coating has de-wetted from the surface of the plastic SOIC which is not uncommon. Plastic parts often have release agents or mould compounds on the surface which can make coating adhesion difficult to maintain or de-wet on application. The same can sometimes be seen with water based coatings

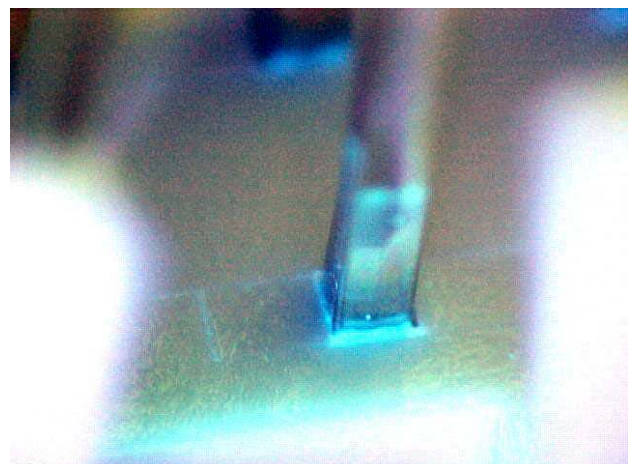
## Coating Penetration on Pins

Conformal coating has penetrated through the connector body along the pins due to capillary action. The coating is visible under inspection with UV light. This may occur during dip coating if the method of masking has not been properly considered or with poor spray application

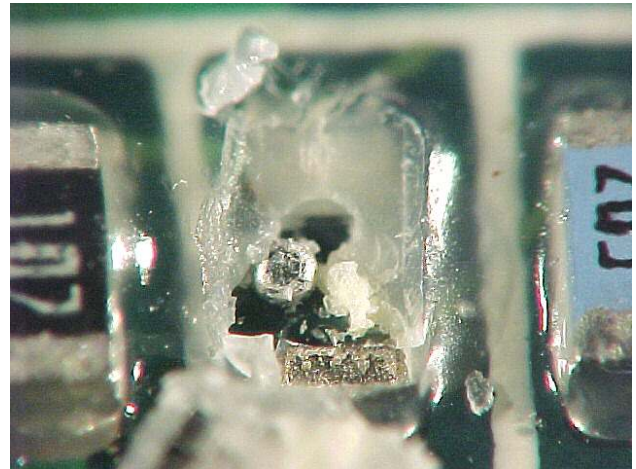
### Solder Balls Under Mask

Solder balls or beads are present under the coating, they are related to the assembly process and not related to coating. Solder balls can be present on the surface of the board when a no clean process is used. If a cleaning process is used it must be capable of removing the balls. Ideally the root cause during the soldering process should be determined

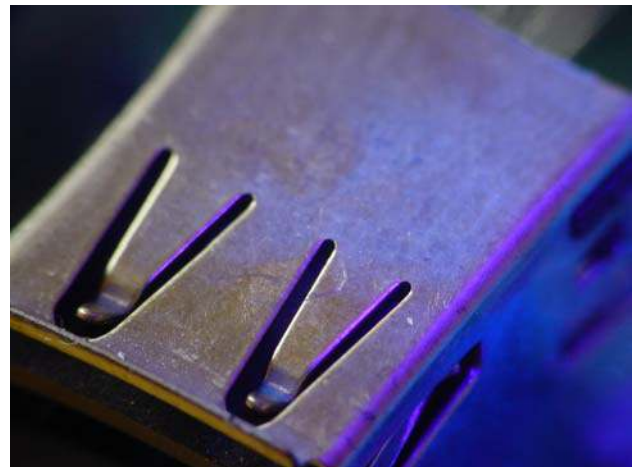
### Coating Contamination

Contamination on the outer surface of the connector body may be over spray, poor programming of the spray system or poor masking. Overspray of the coating is easily seen during inspection under UV light and may or may not require rework of the product

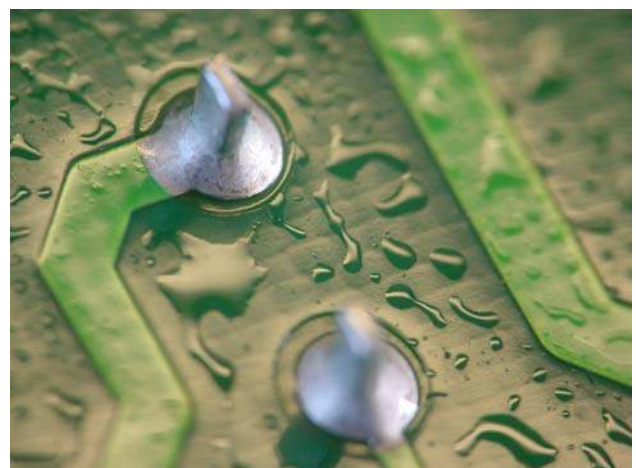
### Surface Mask De-wetting

Solder mask compatibility issues with no clean flux is well known, when conformal coatings are evaluated the mask type should be defined and should not change without documented confirmation on the compatibility with the coating

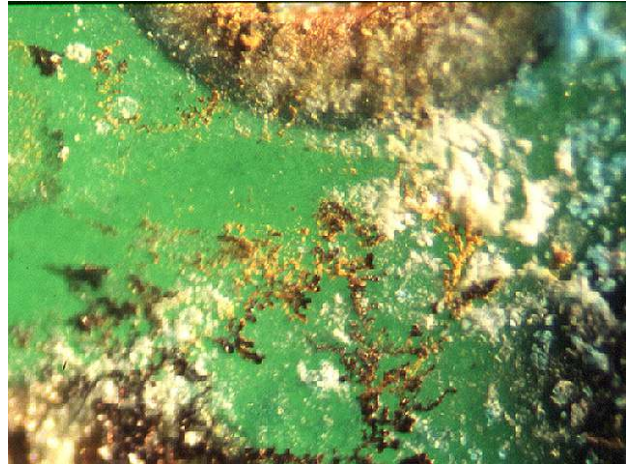
## Surface Corrosion/Dendrites

Surface corrosion has taken place on the surface of the board with incomplete coating protection. The surface of the board must have had some ionic residues on the surface, the presence of this contamination, humidity and applied voltage has allowed copper dendrites to form

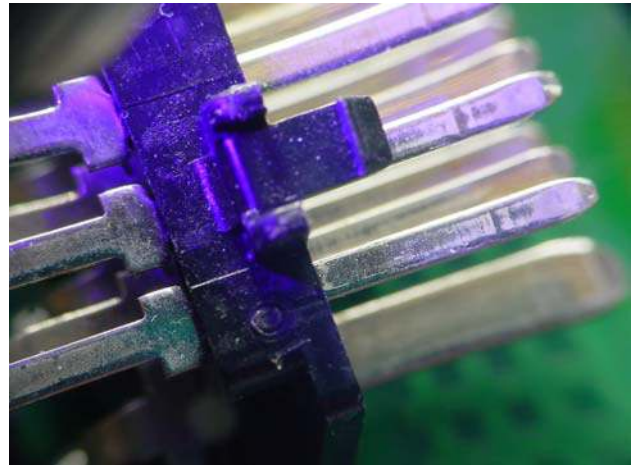
## Coating Contamination

The connector body and contact pins show evidence of coating contamination which may affect the contact resistance of mating pins. The contamination may be the result of over spray, poor programming of the spray head or incorrect masking of the connector

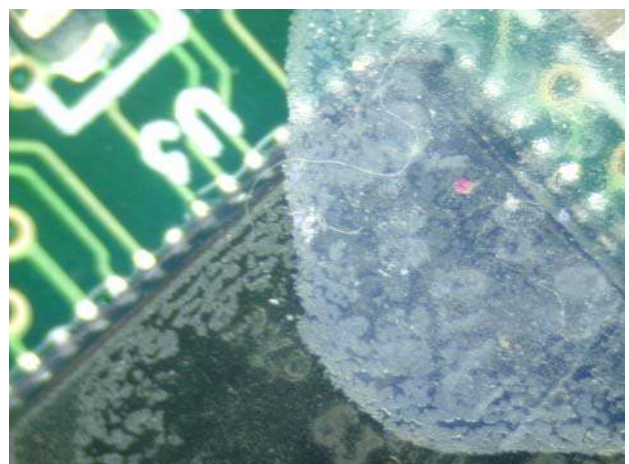
## Coating Lifting on QFN

Coating has separated from the surface of the plastic QFN/LGA body which is not uncommon on many plastic parts. Devices often have release agents on the surface which make coating adhesion difficult to maintain, minor loss or separation may not normally be reworked. In this case the root cause should be established

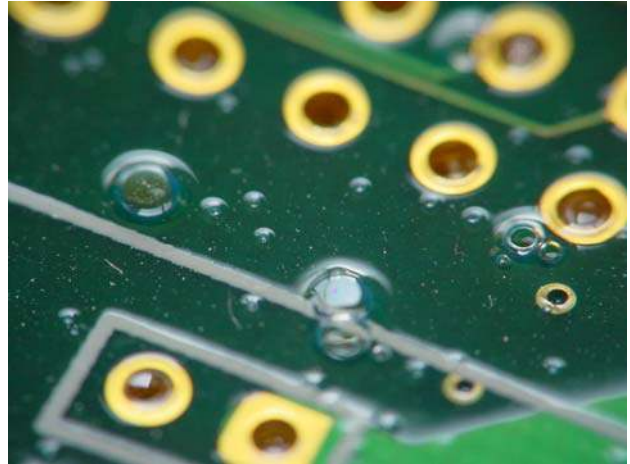
## Coating Bubbles

Bubbles on the surface of the board can be a result of surface contamination; moisture on the surface or in the coating can result in bubbles during static or forced curing. Bubbles are considered a defect but are less likely to be a problem if not associated with component terminations or across conductors

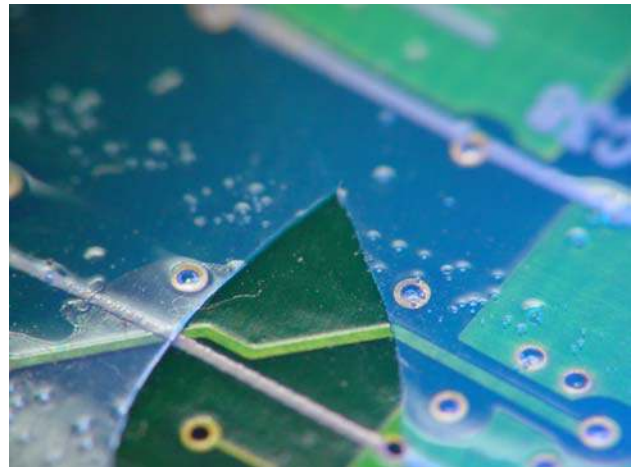
## Coating Delamination

Coating has separated from the surface of the board which will have been caused by contamination under the mask. Delamination can be seen as blisters, bubbles, peeling, non-wetting or, as in this case cracking/peeling. The way in which the coating separates from the board will be dependent on the type of mask, thickness, cure and point of failure

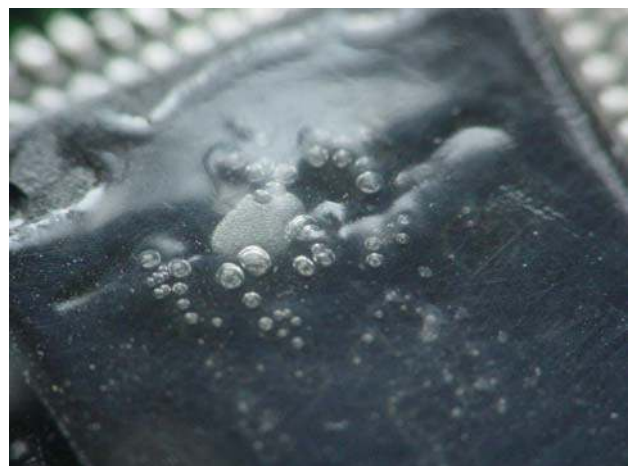
## Excessive Coating Thickness

Coating thickness is defined by the process used during application. With automation consistent thickness is easier to achieve. Manual methods and rework are less likely to control thickness, although not necessarily unreliable every effort should be used to maintain thickness control to the specification

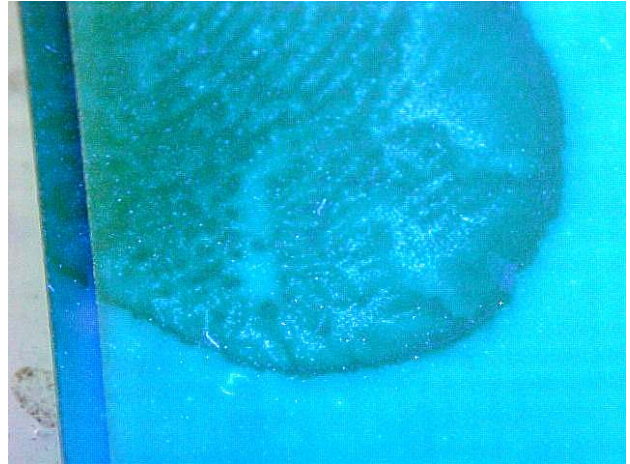
## Fingerprints

All printed boards should be handled by their edges to avoid contamination. Every effort should be made to avoid manually handling coating or partly cured boards to avoid leaving residues and handling marks

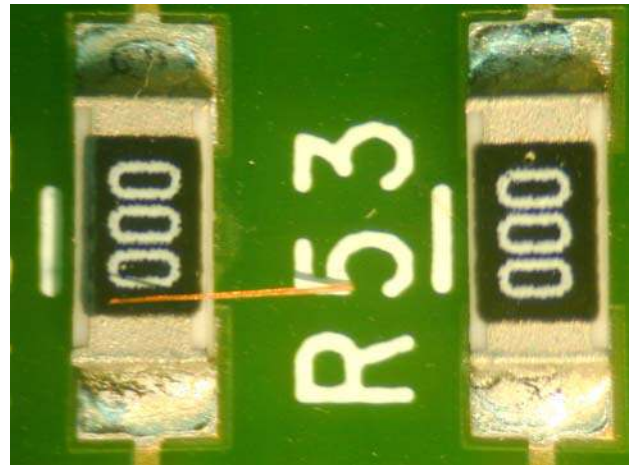
## Brush Fibres

Whenever a brush is used during the removal or recoating operation fibres can be left on the surface of the board. If found every effort should be made to eliminate the source of the contamination for future assemblies. A properly cleaned board should remove all evidence of fibres but, provided they do not bridge the active circuit or terminations, are they an issue?

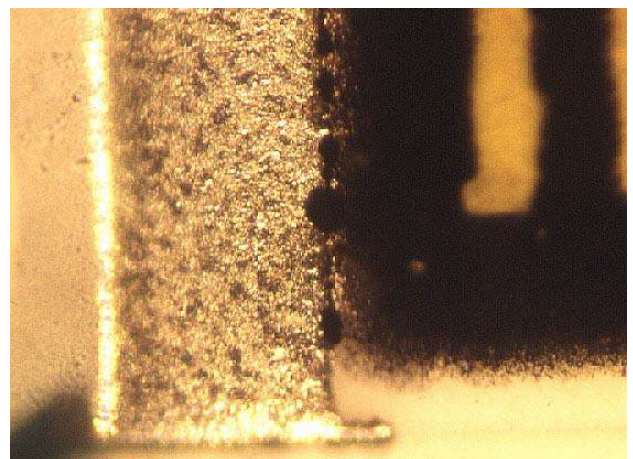
## Sulphur Corrosion

Sulphur environment has shown corrosion to printed boards and component terminations. In the example black sulphur blooms are seen at the termination of the resistor which led to changes in resistance. Coating of assemblies may inhibit the speed of sulphur corrosion but not stop it completely

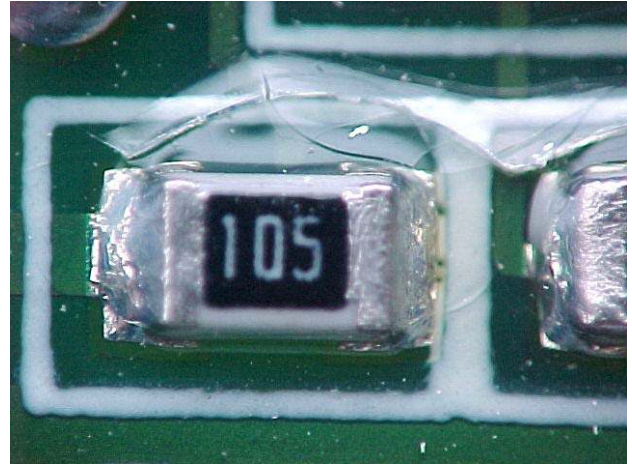
## Coating Cracking

Cracking of a coating is most commonly associated with mechanical stress which could be caused by temperature cycling, expansion of residues or volatiles under the mask. Cracking of a mask may be exaggerated by a change in the mask characteristics due to thickness applied or over curing

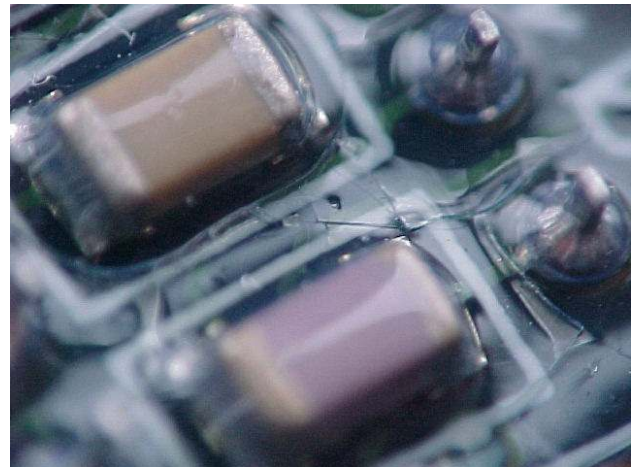
## Coating Cracking

Cracking of a coating as compared to peeling is associated with a brittle material or a product that has become brittle. Care should be taken that the material is correctly selected for the application and cured in line with supplier's recommendations

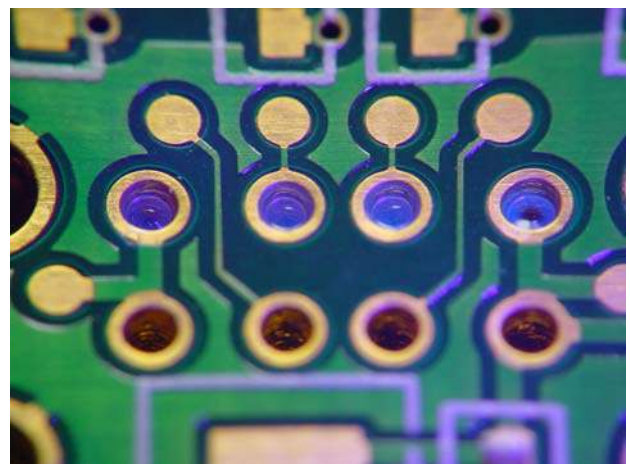
## Coating Penetration

The coating material has penetrated from sided one to side two along the plated through holes. Coatings can capillary through small vias and routed areas. The coating was visible during inspection with UV light, if the contamination is an issue on side two the holes should be masked correctly

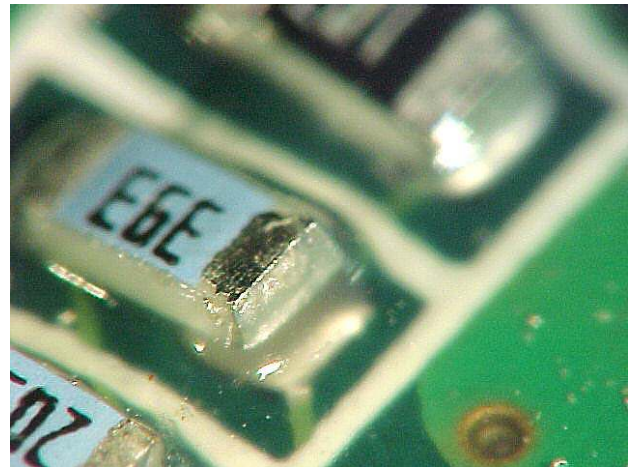
### Open Solder Joint

Chip resistor was found to be open circuit, the part had lifted during reflow and the open connection not detected. The coating has successfully been applied and cured over the board assembly. Clearly this should have been detected by electrical testing prior to coating

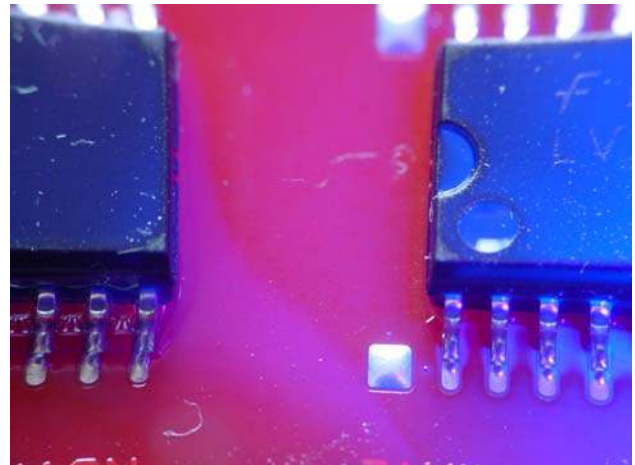
### Coating Shadowing

The coating is varying in thickness due to the proximity of the two small outline devices and the process parameters used. The process used for coating should be re-examined to improve the coating consistency on what is not a demanding design

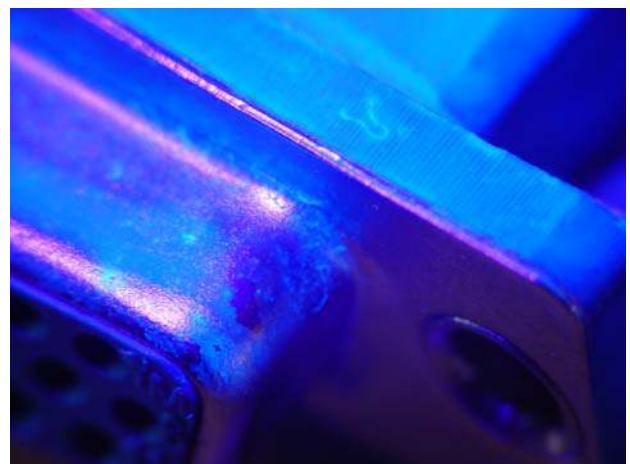
### Excessive Coating Contamination

Incorrect or poor masking has resulted in contamination on the surface of the connector body. Contamination can also be related to incorrect setting of a selective spray application process

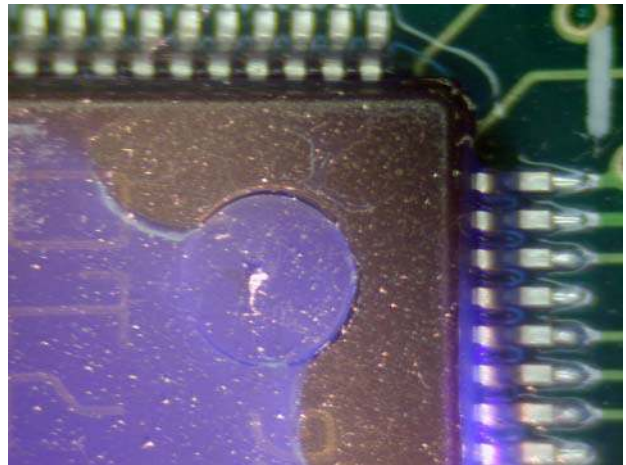
### Coating Lifting/Peeling

Coating has lifted from the surface of the plastic quad flat pack body. It is well known that the adhesion to plastic devices may be poor but in this case the coating has been mechanically damaged during handling

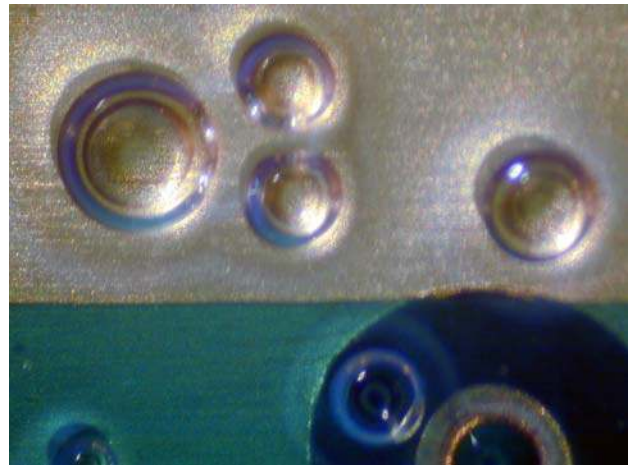
### Fish Eye Bubbles

Often the term is applied to normal bubbles on the surface of a board. The larger bubbles can be associated with small particles or surface of contamination on the surface causing local non wetting and a void to form

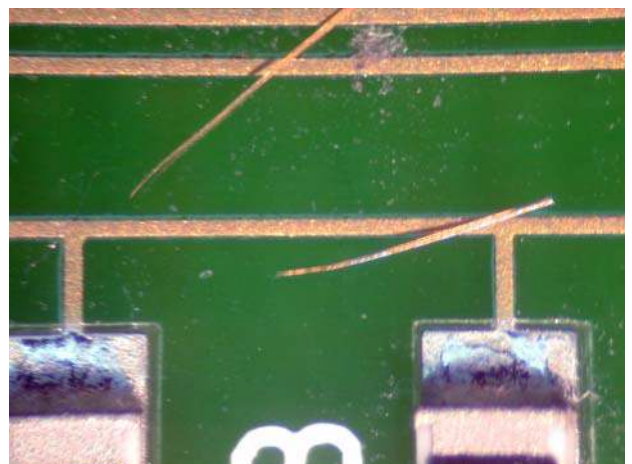
### Brush Hairs

Brush hairs are visible in the surface of the coating, the hairs may have come from a manual brush coating process or from a brush used to remove a coating during rework. Every effort should be made to prevent this occurring on future products but as the hairs do cross conductors they may not be acceptable

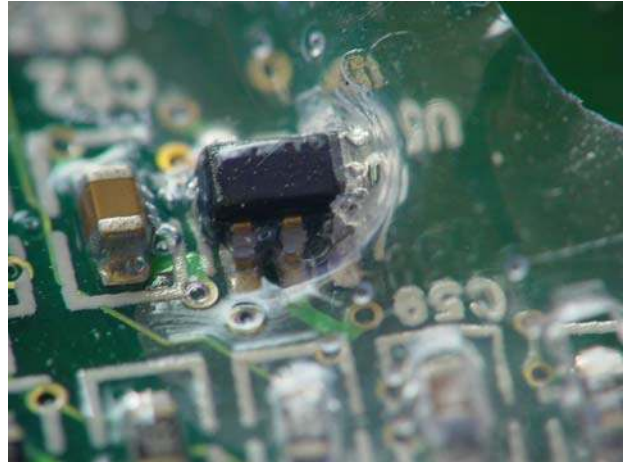
## Bubbles and Coating Lift

Surface contamination under the coating around the SO package has reacted and lifted the coating. Analysis may show the type of contamination causing the corrosion to occur

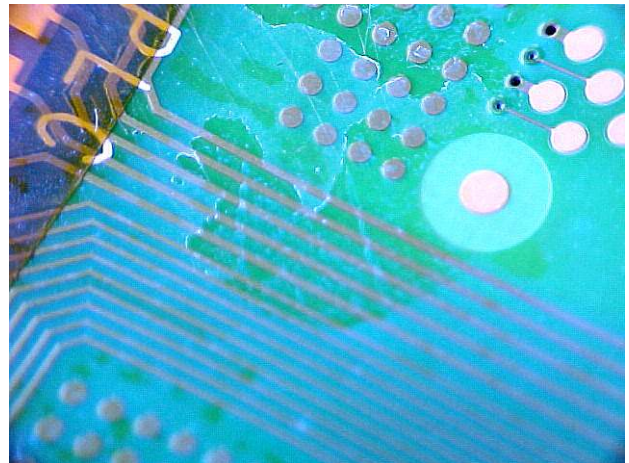
## Surface Contamination

Poor manual handling of the board assembly prior to coating has resulted in poor coating adhesion. Boards should always be handled by their edges after cleaning or in a no clean assembly process

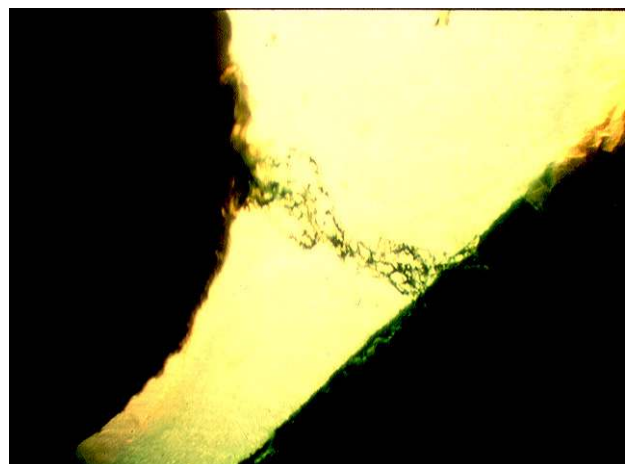
## Copper Dendrite Formation

Dendrite formation is seen between two conductors with back lighting. Dendrites will cause intermittent connection between adjacent points if formed at high temperature, humidity, applied voltage or where high levels of contamination are present on the surface of a board

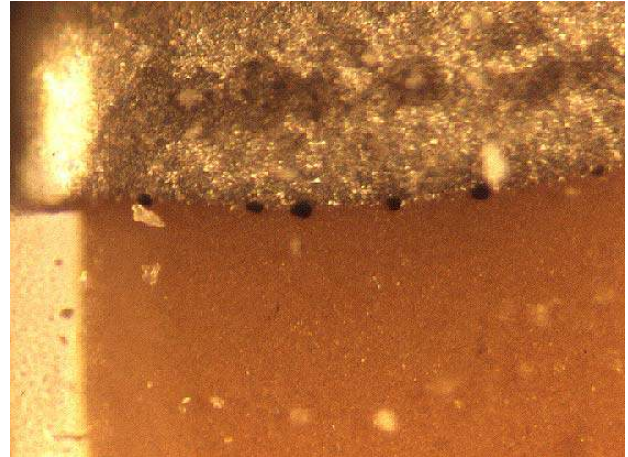
## Sulphur Corrosion

Exposure to a sulphur environment can allow black sulphur bloom to form on terminations, black marks on the silver contacts is seen under the coating. This did not lead to problems on this capacitor but connection loss on other chip resistors. Coating of assemblies may inhibit the speed of sulphur corrosion but not stop it

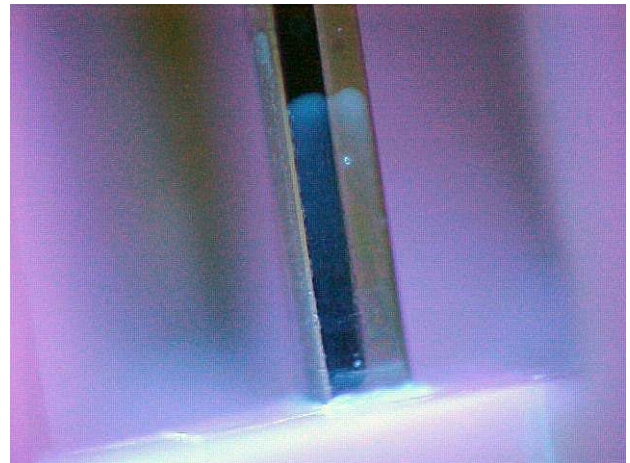
## Coating Contamination

Inspection of the printed board assembly under UV light shows surface contamination of the connector pins. Contamination of the pins may be a result of poor masking, spray application or coating penetration through the connector body

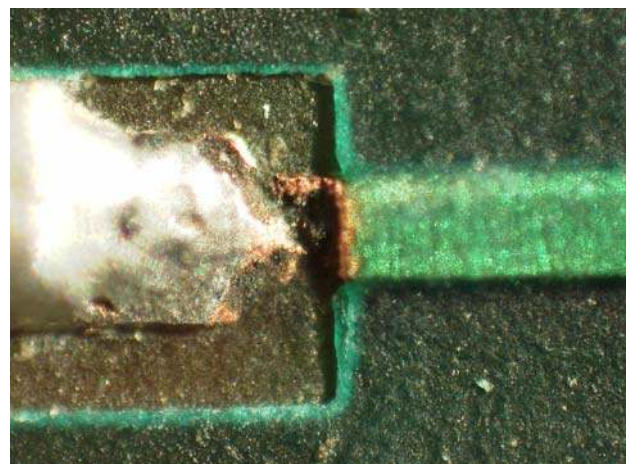
## Sulphur Corrosion

Printed circuit board copper track shows significant corrosion on an open circuit on the pad due to sulphur. A combination of exposed copper/silver surfaces in a sulphur gas has allowed corrosion to occur. Conformal coatings are known to slow down the reaction but not eliminate this happening

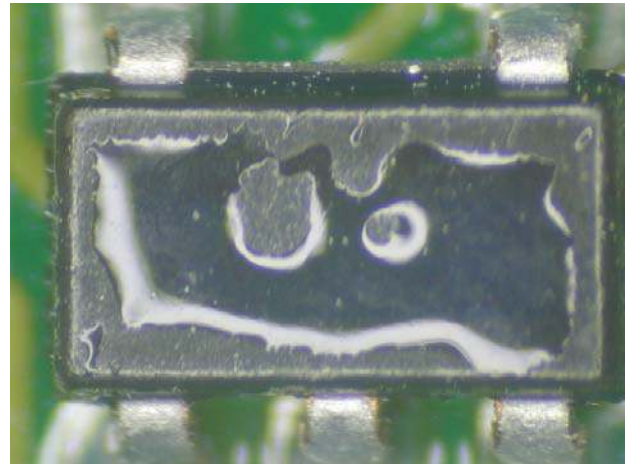
### Coating De-wetting/Pullback

The coating has de-wetted/pulled back from the body on this SO package. This type of effect is most likely to be related to the surface of the component and any surface contamination. This is not uncommon and difficult to overcome in a no clean process with plastic components

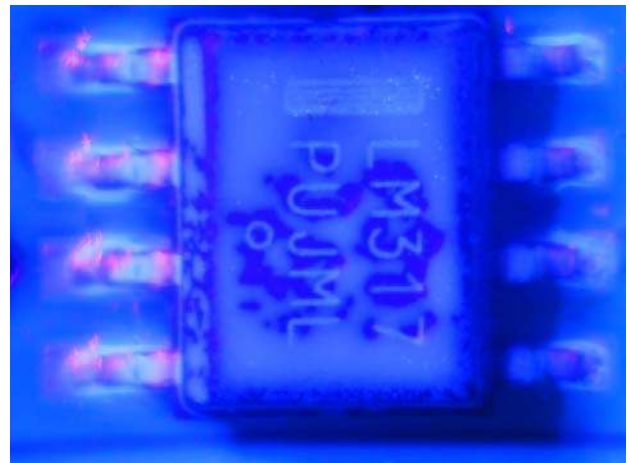
### Uneven Coating Coverage

The coating thickness is uneven on the surface of the SOIC. This is most likely to be contamination on the surface of the component than a coating application defect

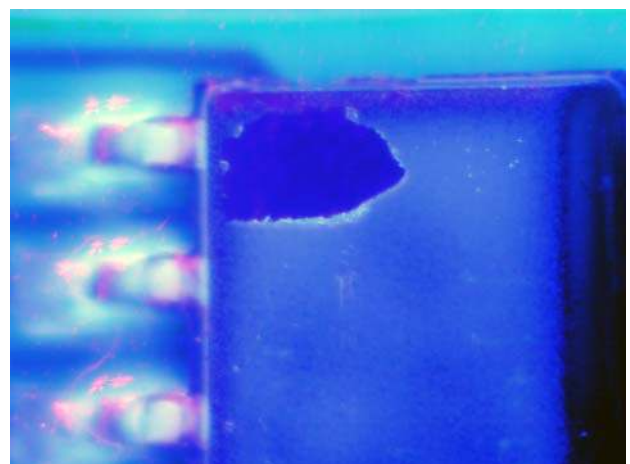
### Chipped UV Coating

Damaged coating on a SOIC body found during UV inspection. The coating is either chipped or peeling from the surface of the plastic component

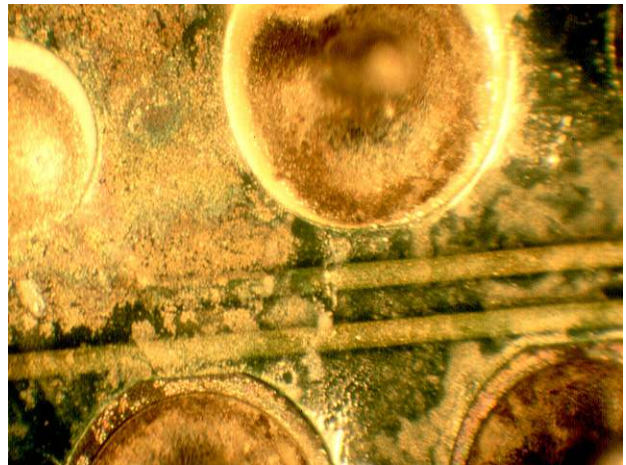
## PCB Corrosion Under Coating

Excessive flux residues under the conformal coating have caused corrosion between two terminations. This is probably associated with a rework operation prior to coating. In a no clean process the complete process and all soldering materials must be evaluated with the coating

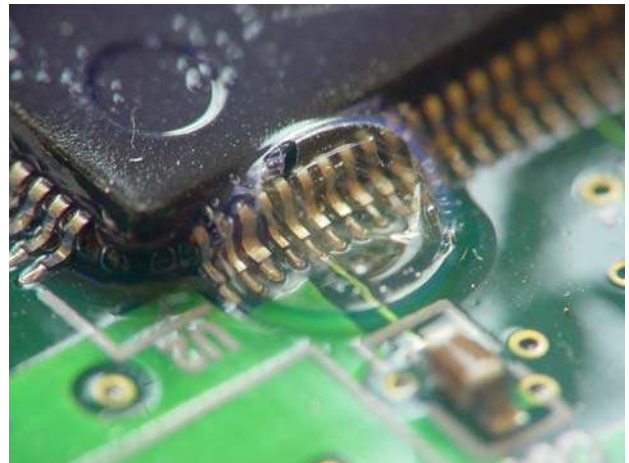
## Solvent Outgassing

Bubbles around large components are often experienced after conformal coating and curing. The bubbles can be formed by trapped air or solvent expanding under the mask leaving no coating between terminations

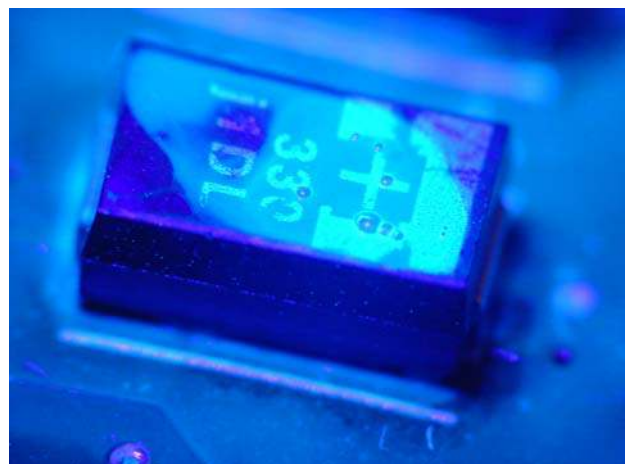
## Incomplete Coating Coverage

The coating process has not completely covered the surface of the component body. Inspection under UV light does show that all other areas have been coated

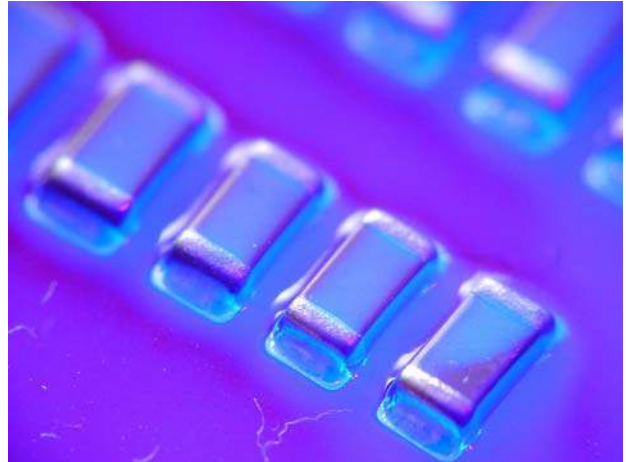
### Coating Missing on Capacitor

The coating process has not completely covered the surface of one capacitor but could simply be touched up manually. Inspection under UV light does show that all other components and PCB surfaces have been coated

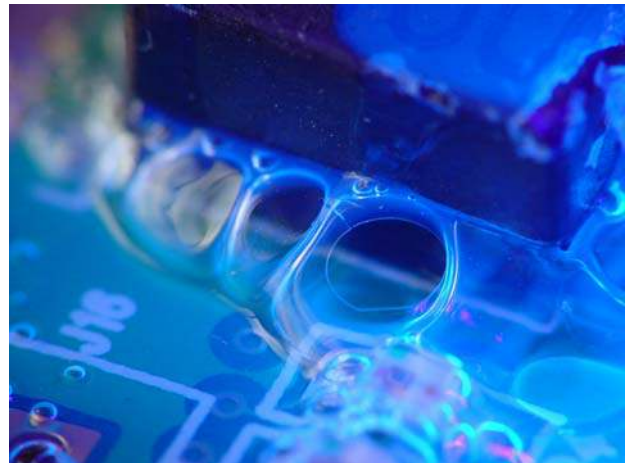
### Excessive Coating Bubbles

Bubbles around large components are often experienced after conformal coating and curing. The bubbles can be formed by trapped air or solvent expanding under the mask, often this is seen during forced curing

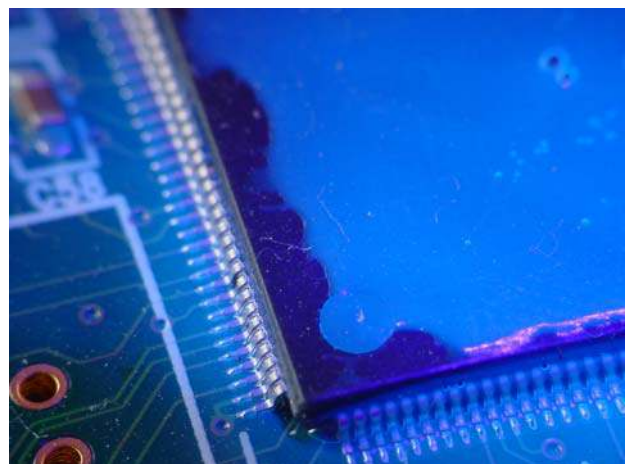
### Incomplete Coating Coverage

The coating has not completely covered the QFP and is seen under UV light inspection. The surface of the board and terminations are coated. The coating may have pulled back from the edges after application

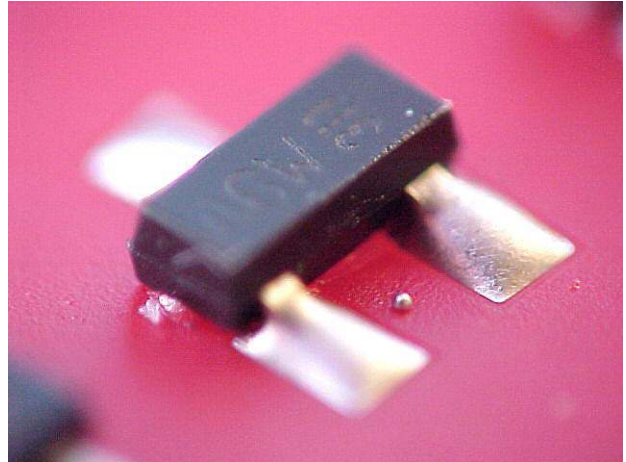
### Satisfactory Coating with Parylene

The solder ball is not ideal but the coating would prevent the ball on this assembly from ever moving as defined in the IPC inspection criteria

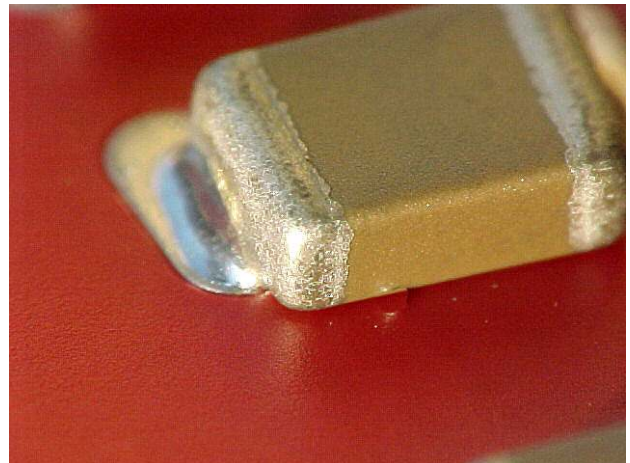
### Satisfactory Coating with Parylene

The coating thickness applied to this board assembly was 15um and there is no visible evidence of the coating on the surface. The capacitor is misplaced from the pad but still within the IPC inspection criteria

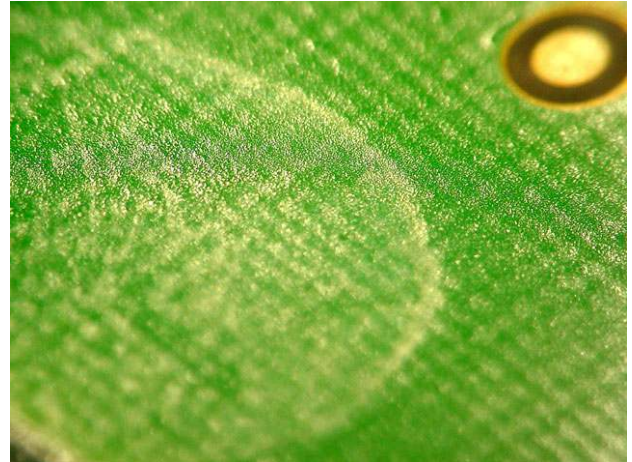
## Fingerprint After Coating

Printed circuit boards should be handled by their edges to avoid fingerprints. Every effort should be made to avoid handling coating or partly cured boards to avoid leaving obvious marks

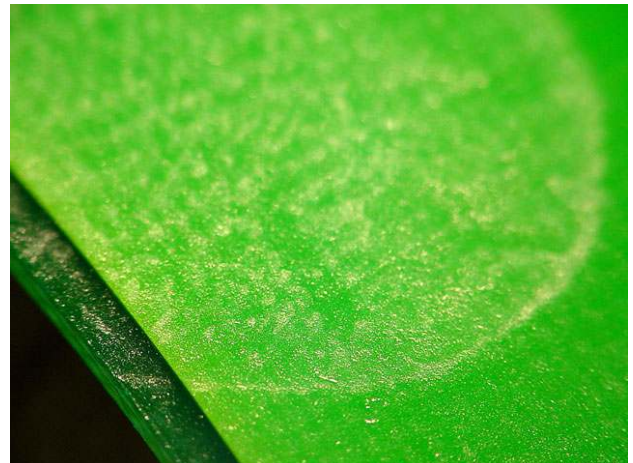
## Fingerprint Before Coating

Printed boards should be handled by their edges to avoid fingerprints. The image shows the result of handling the board and leaving residues on the surface prior to coating. The finger print location is visible on the surface of the mask after curing

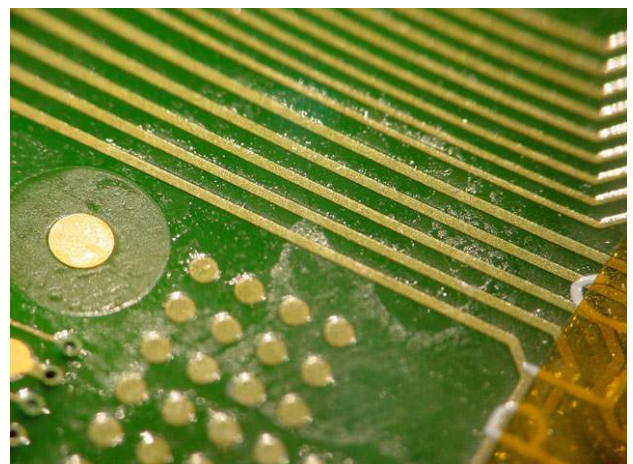
## Surface Contamination

Contamination on the surface of the first off board inspected has prevented the coating wet the surface. It may be necessary to clean or re-clean the batch of boards prior to coating the batch

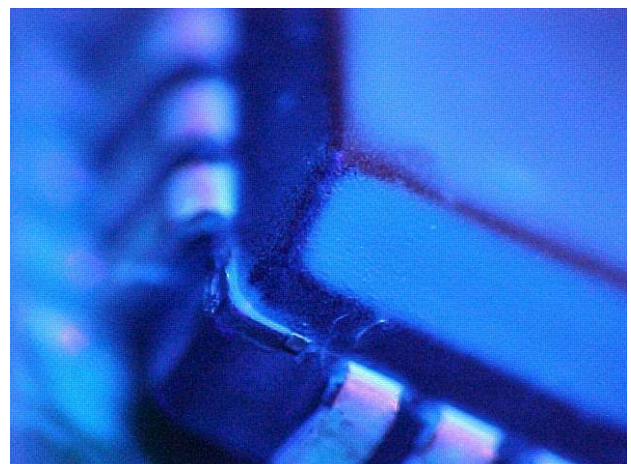
### Satisfactory Coating under UV Light

The spray coating on the surface of the board and solder joints is satisfactory but there is some evidence of pull back of the coating on the edges of the plastic component body

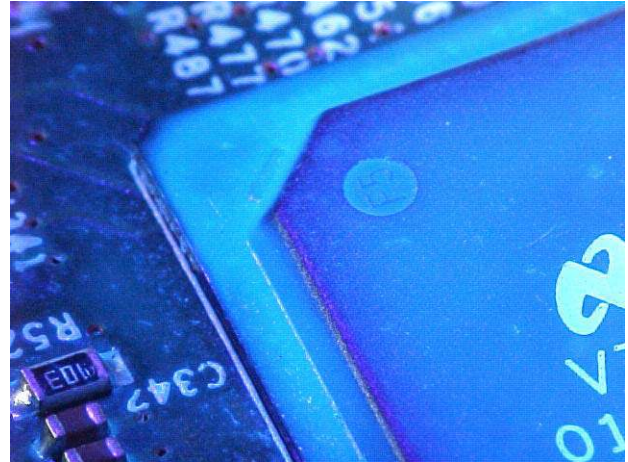
### Coating under UV Light

BGA body is coated but there is evidence of poor coverage on the board around the package which may be related to the cleanliness of the assembly

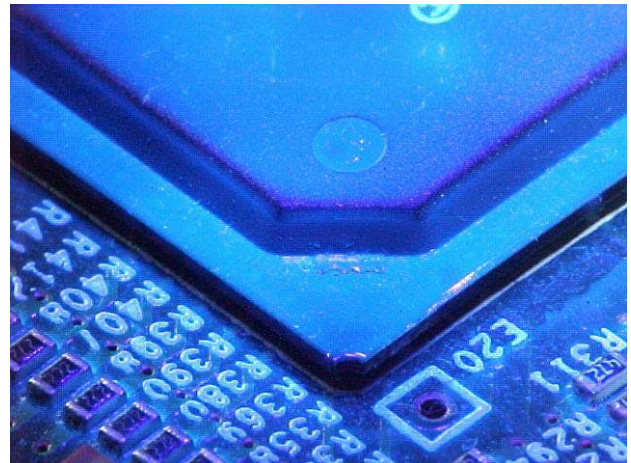
### Coating under UV Light

BGA body is coated but there is evidence of poor coverage on the board around the package which may be related to the cleanliness of the assembly

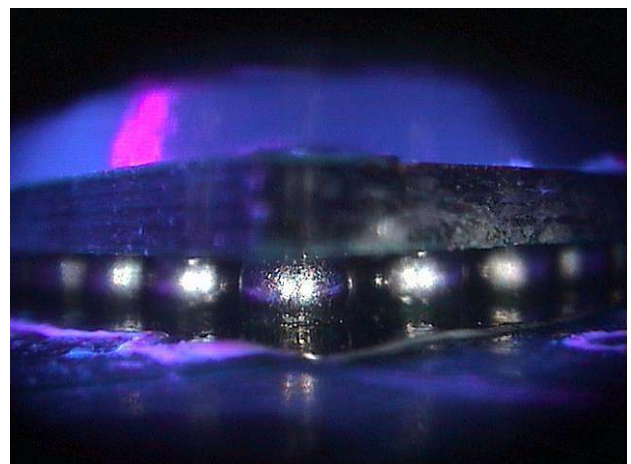
### Satisfactory Coating under UV Light

Satisfactory coating on the body of the BGA and the board surface is highlighted with UV inspection. There is no evidence of the coating under the BGA on the joint areas which is not uncommon with spray coating
