# CONFORMAL COATING PHOTOGRAPHIC GUIDE

# CONFORMAL COATING INSPECTION & DEFECT GUIDE

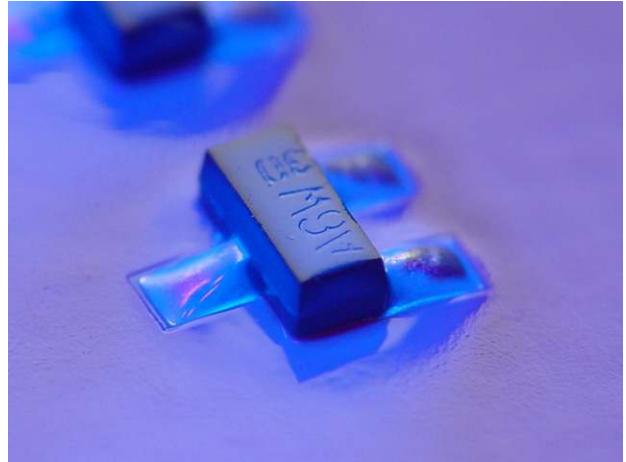
Satisfactory Coating under UV Light

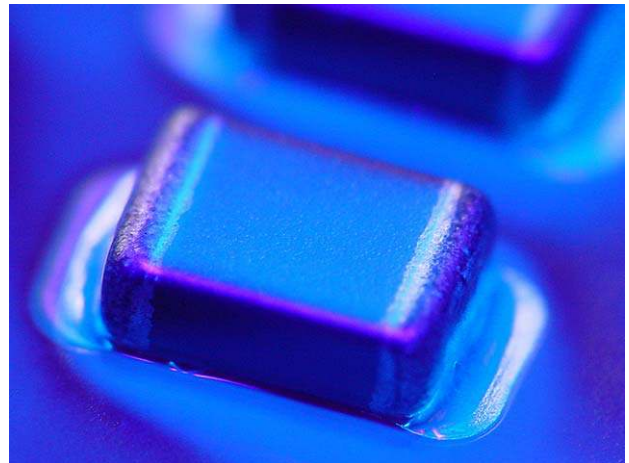
Satisfactory Coating under UV Light

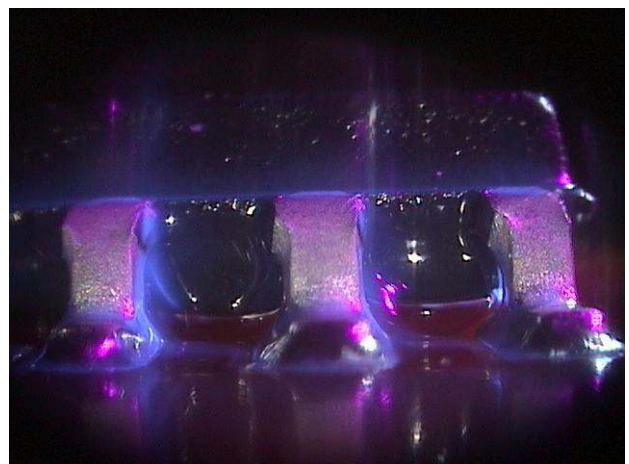
Satisfactory Coating under UV Light

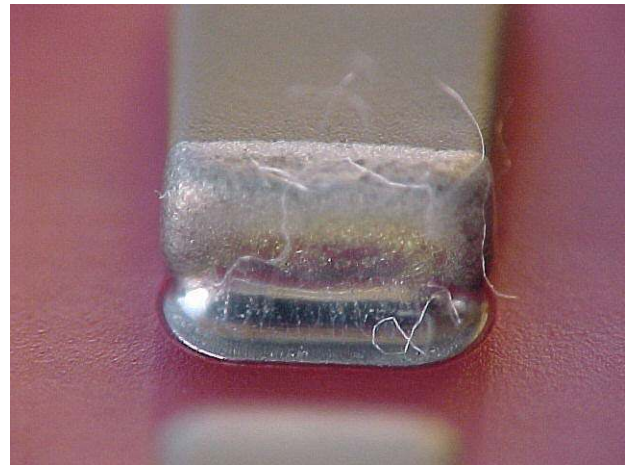
### Satisfactory Coating with Parylene

The problem with this coating is there is nothing to see on this 15um layer. Correct process control and parameters defines the deposited thickness which can be confirmed with a test card. Alternatively, a label or stamp is applied to the board surface prior to coating

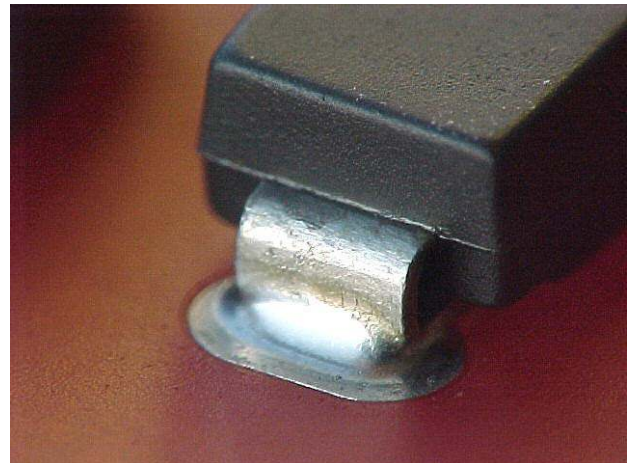
### Satisfactory Coating with Parylene

The coating thickness applied to this board assembly was 30um and there is no visible evidence of the coating on the surface. Some Parylene coating do now come with a UV trace but are more expensive

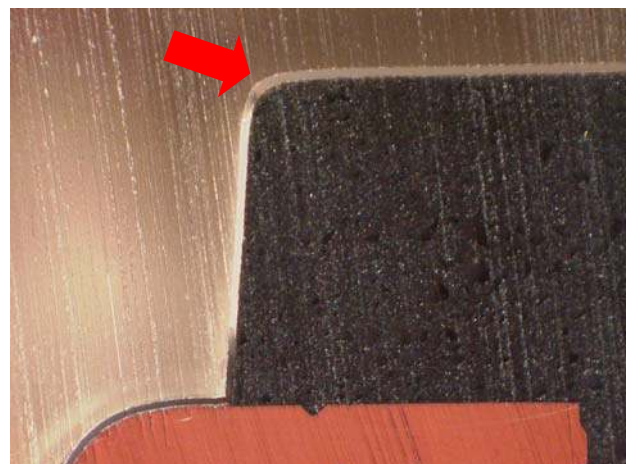
### Satisfactory Coating with Parylene

The microsection image shows the coating perfectly forming over the surface of the package and lead

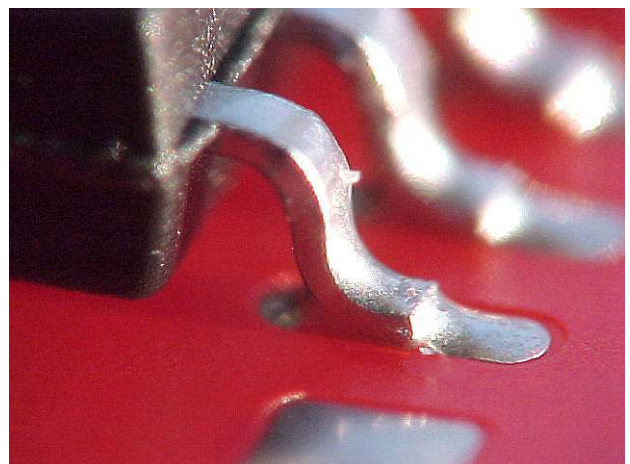
### Satisfactory Coating with Parylene

The coating thickness applied to this board assembly was 15um and there is no visible evidence of the coating on the surface

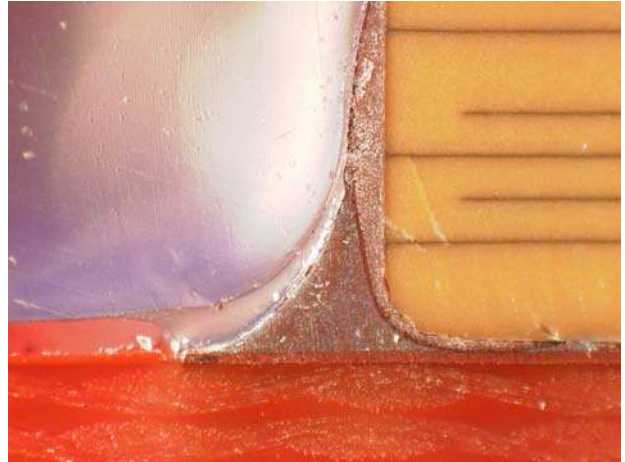
### Satisfactory Coating

Microsection examination through a component termination shows the conformal coating on the surface of the mask and component body

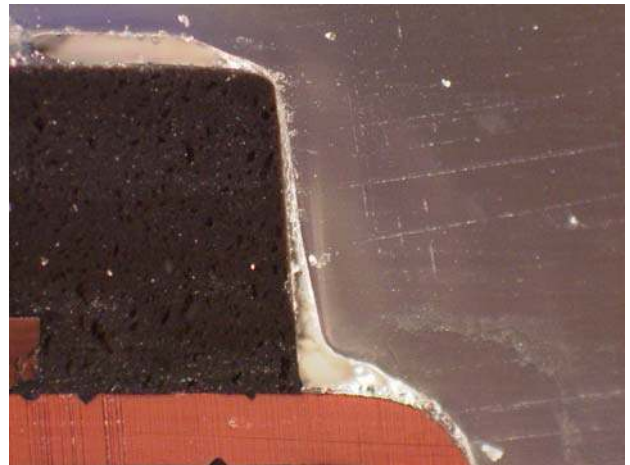
### Satisfactory Coating

Microsection examination through a component shows the coating on the body and lead of the component. The section shows the variation of coating thickness which is normal for traditional dip and spray coating

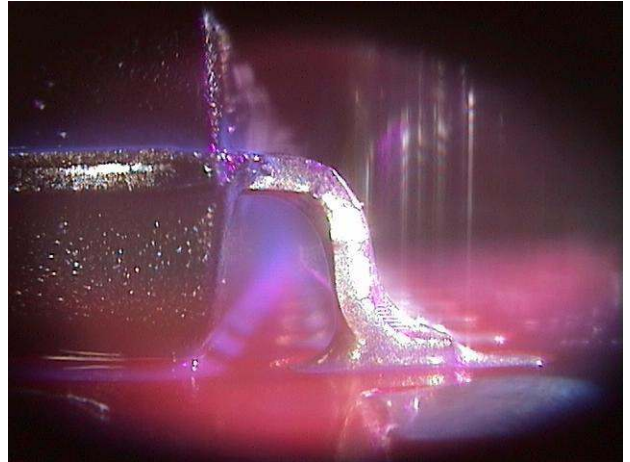
Satisfactory Coating under UV Light

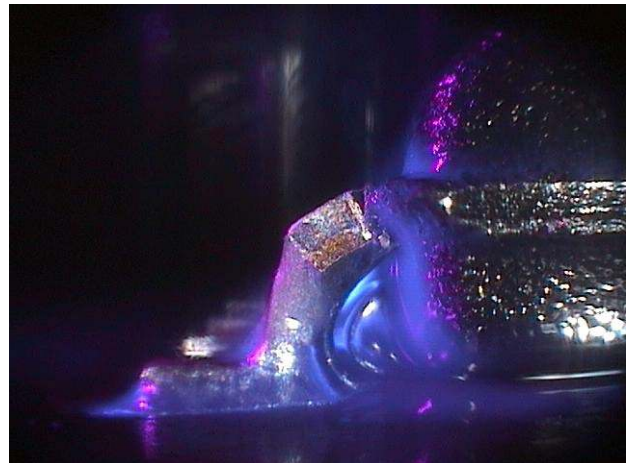
Satisfactory Coating under UV Light

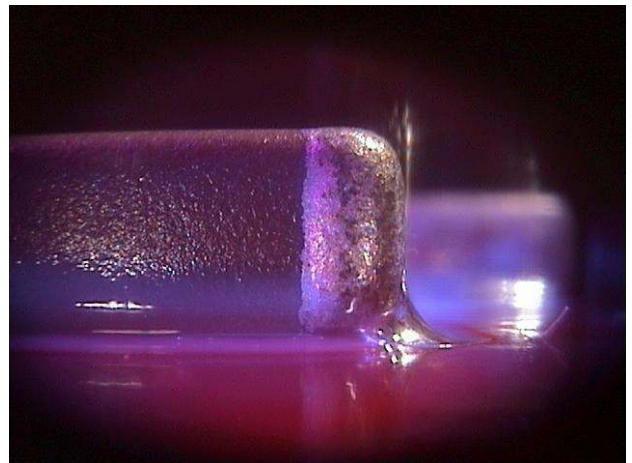
Satisfactory Coating under UV Light

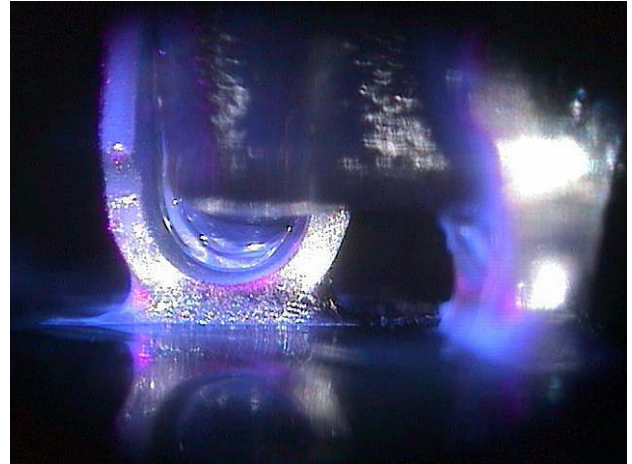
### Satisfactory Coating under UV Light

Conformal coating on one J lead of a PLCC package

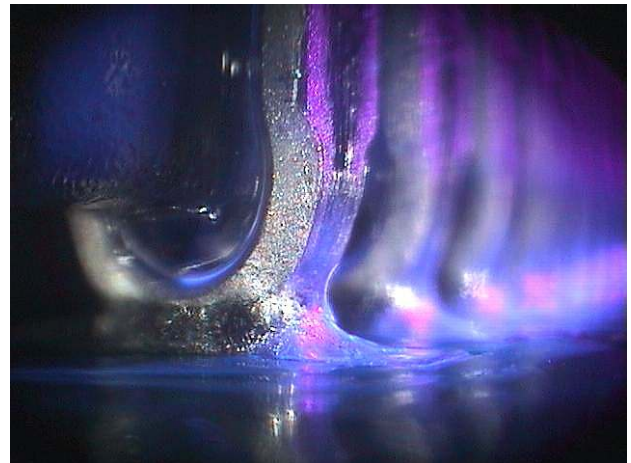
### Satisfactory Coating under UV Light

Coating on PLCC J lead solder joints and package after conformal coating

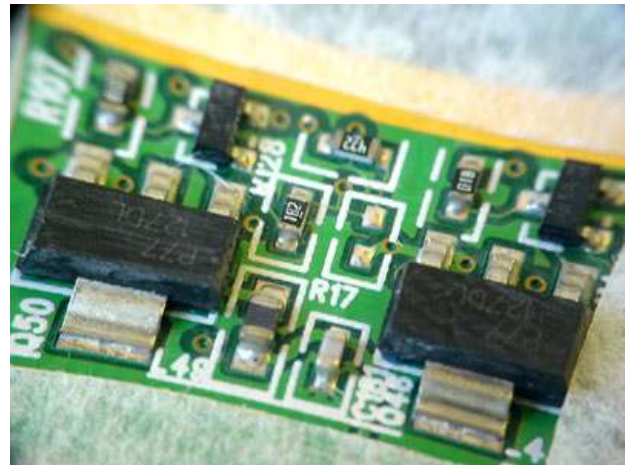
### Coating prior to rework

Printed circuit board assembly with masking tape added prior to removal of the coating. The tape has been added to prevent the solvent attacking coating on other areas of the board assembly

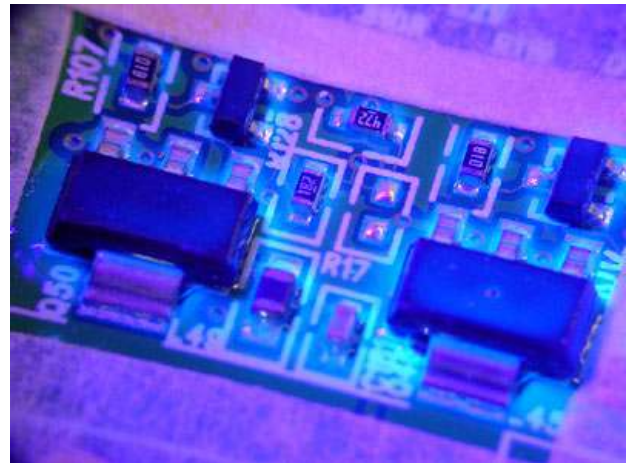
### Coating under UV Light

Partial removal of the conformal coating with solvent can be seen. There is still evidence of the coating around components and terminations

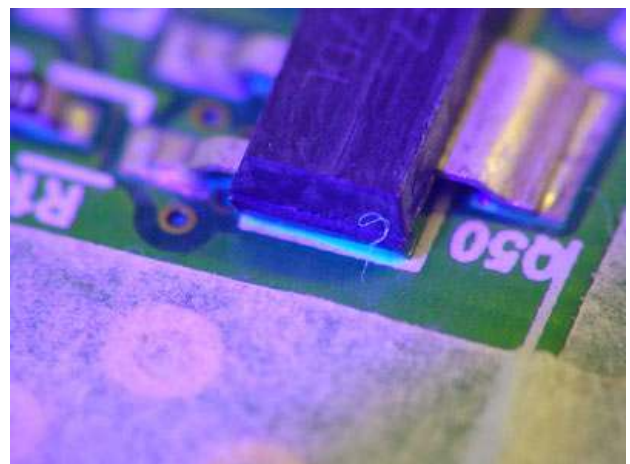
### Coating under UV Light

Satisfactory coating removal can be seen on the board assembly. Some evidence of coating under the body of component remains but should not make rework difficult
